Project: Camp Seagull

In late June, Beckett & Raeder completed the project inventory scope of our work plan and assessed the recent construction at Camp Sea-Gull. The new construction includes a boat launch, roads, pathway, parking areas, and other ancillary improvements. The initial inventory scope included a site inventory of Camp Sea-Gull during which we performed a visual assessment of the “areas of concern” previously identified by the Township. Beckett & Raeder staff then met with Hayes Township officials to review and verify that the site inventory information was consistent with the areas of concern identified for incorporation in the final report.

Camp Sea-Gull Report

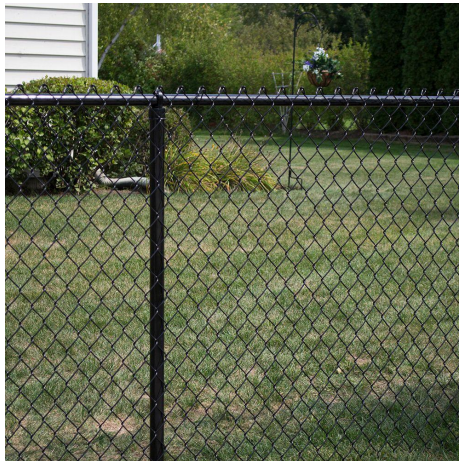
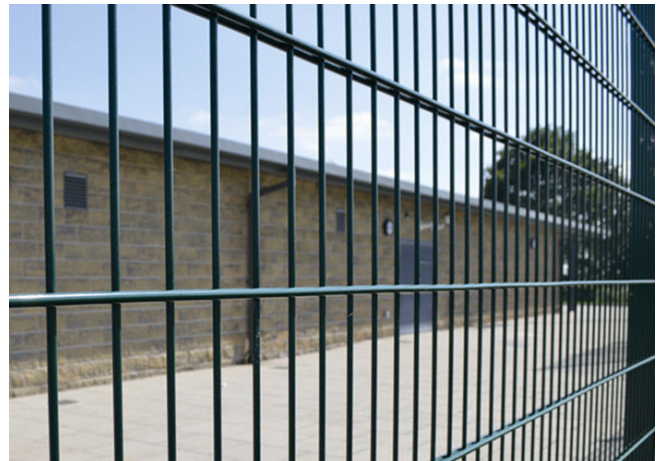
1. The layout to the slope of the driveway to the boat launch, the fishing pier, and the visible erosion to the base of the excavated slope that ends at the edge of the parking area of the fishing pier.

1. A barrier would be needed to retain rock debris and to prevent injury to people and site improvements.
2. A barrier fence and preventative netting were evaluated as remedial measures.
3. The manufacturer of the barrier and netting systems recommended the barrier system.

Our recommendation is to install approximately 550 lineal feet of 6'-8' tall structural barrier fence along the rock wall.

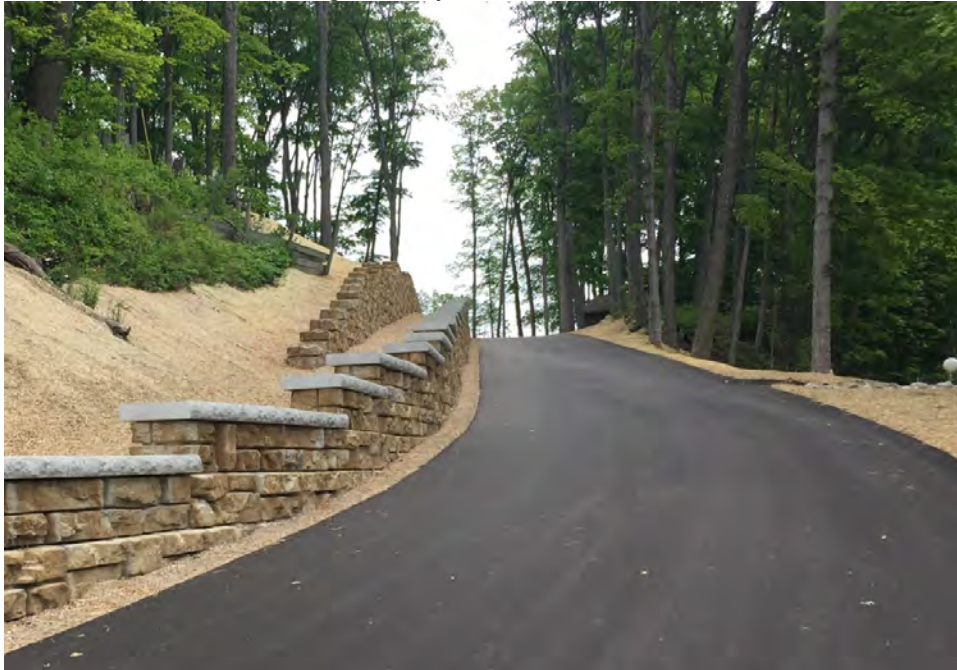
The construction plans specify a 42" guardrail, or timber path barrier adjacent to the turf pedestrian path that descends from the upper parking area down to the boat launch and fishing pier. Portions of the retaining wall between the pedestrian turf path and the bituminous roadway exceed the 30" height above adjacent grade for which construction codes require a guardrail. It is not clear from the records available why the guardrail was not constructed. The fall hazard could be eliminated if the pedestrian turf path could be barricaded and closed, but this would create a hazardous situation by forcing pedestrians to share a steep narrow winding roadway with vehicles and boat trailers.

Photo # - Safety Railing Along the Turf Path Wall Structure

Install the timber path barrier per plan.

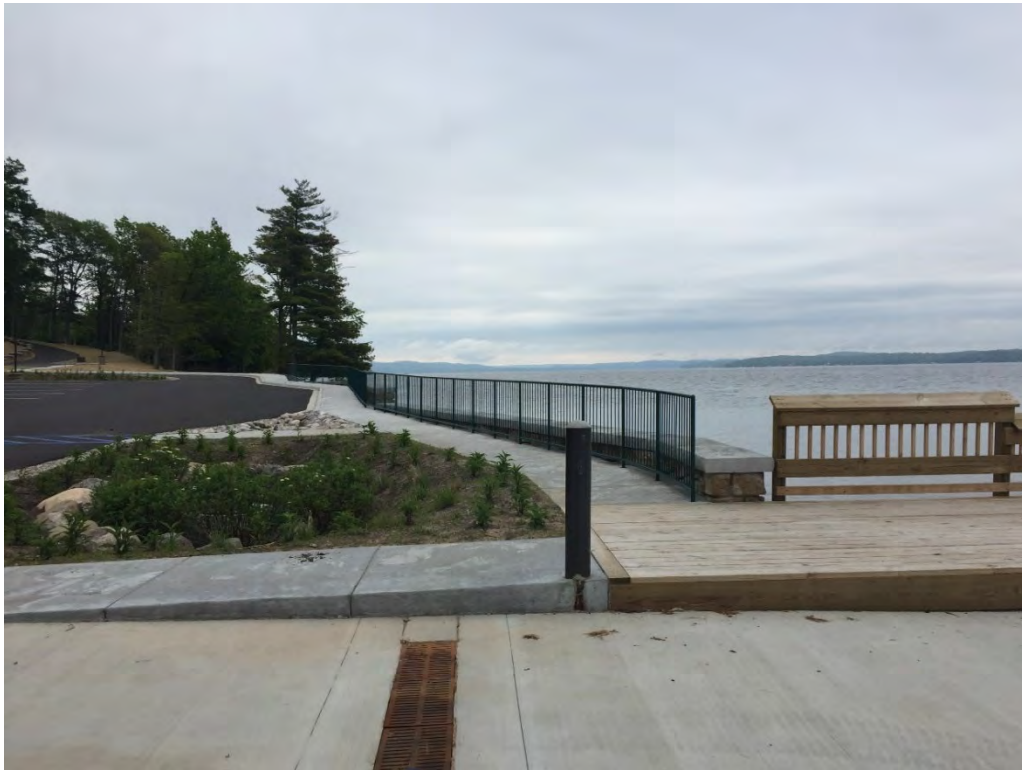
Review and Assessment: The safety rail has been installed. However, there is a gap in the railing over the wall between the wood railing and the metal railing.

Photo # - Safety Rail Along Break Wall

This gap could be filled by bolting an additional 2-feet of railing to the wood post and cantilevering it over the wall.

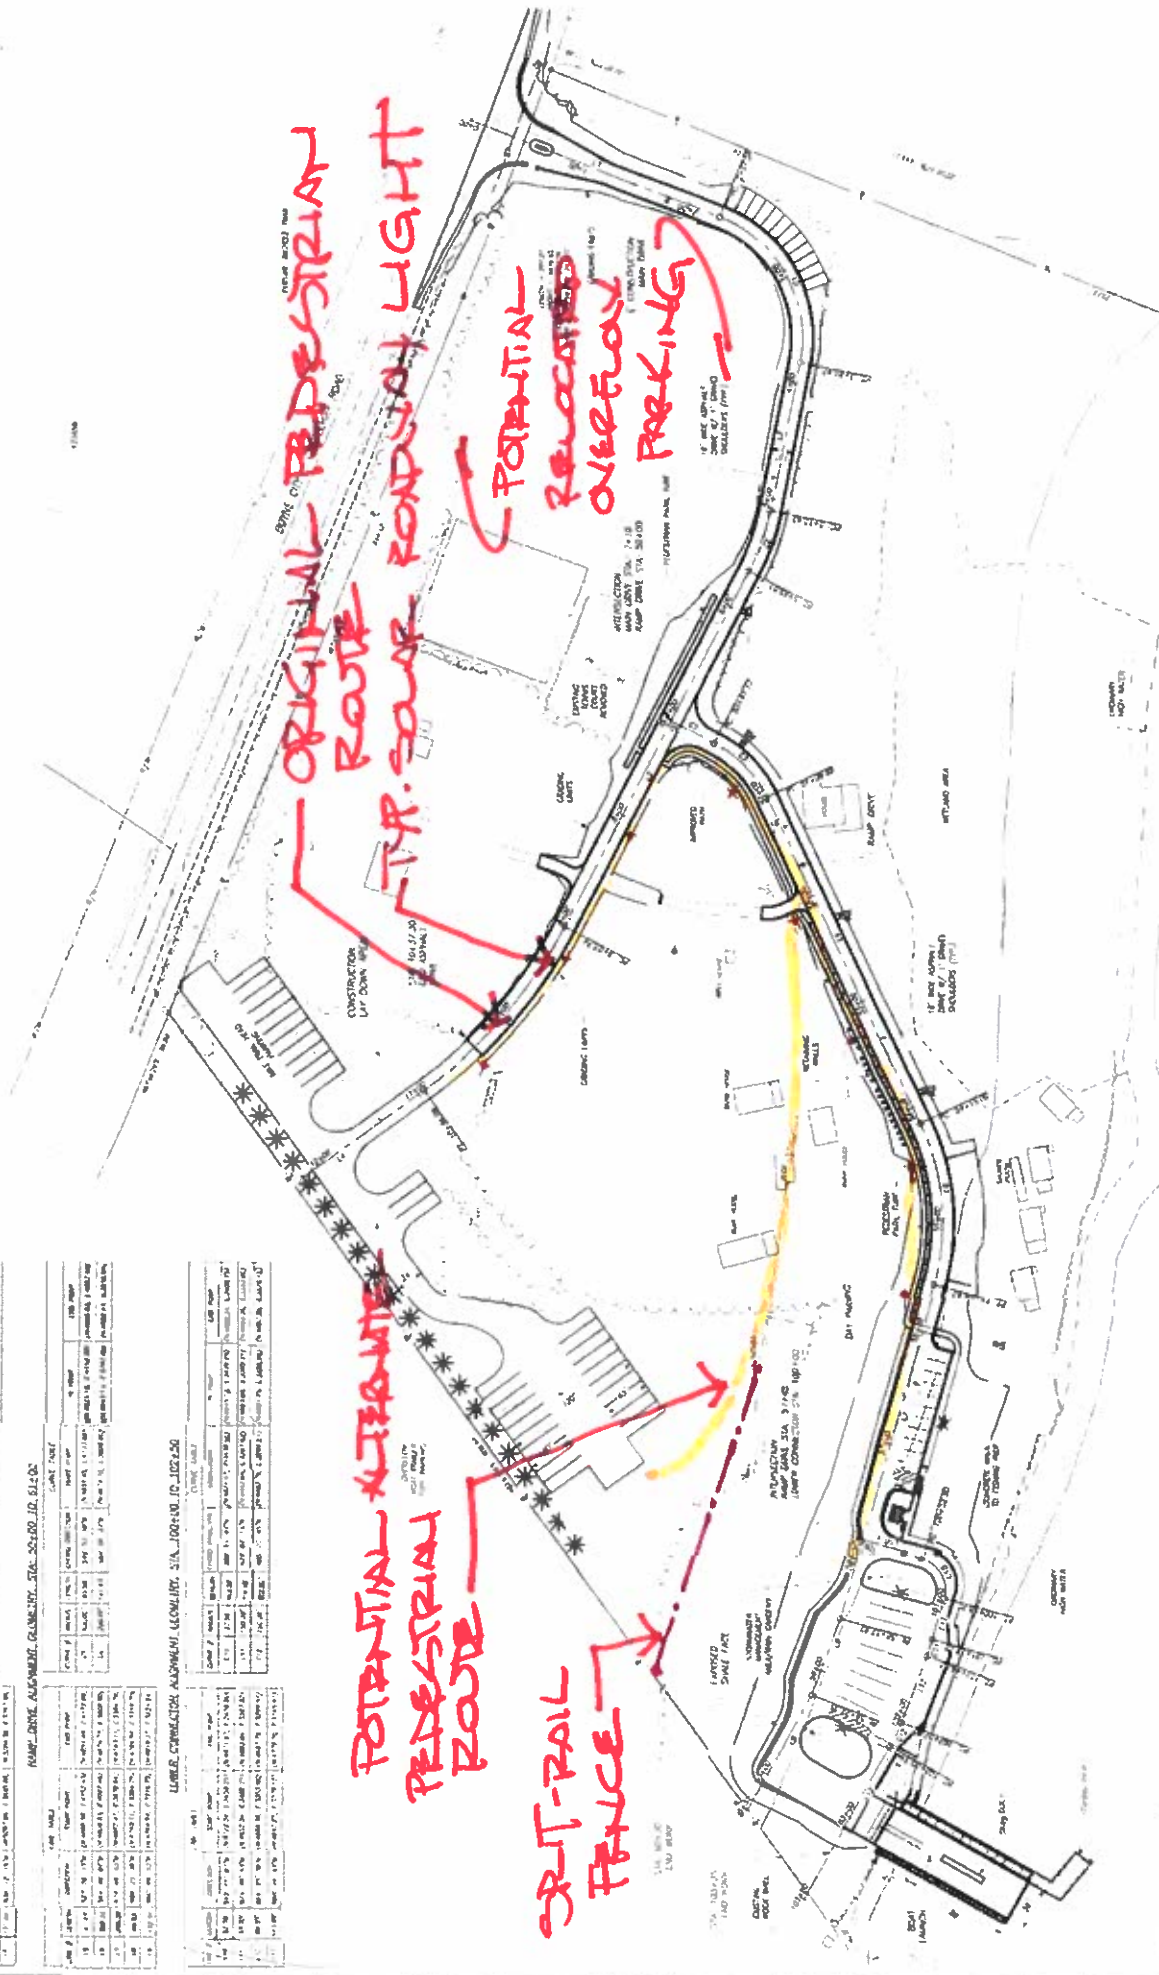
FIGURE 4.1

The pedestrian route from the overflow parking is not well defined nor signed to indicate an intended route. Potential routes a pedestrian could take include:

- Retrace route along the vehicular driveway from the boat launch.
- Shortcut southeasterly past the original amphitheater space and bunkhouses to meet the pedestrian path adjacent to the boat launch drive. Unfortunately, this route presents challenges that a first-time user may not realize until encountering them, such as the steep slope or turf pedestrian path framed by retaining walls.
- Attempt to take the most direct route. Because of the slope between the overflow parking area and the boat launch area, this is unfeasible and unsafe.

1. Area exists to indicate a pedestrian path route from the overflow parking area to the pedestrian path along the boat launch driveway. This route may be able to run past the amphitheater, and along the south side of the two bunkhouses before connecting with the pedestrian path along the boat launch driveway. See Figure 4.1 for potential route options. Should this route be established, we recommend placement of 450 lf of 42" double split-rail fence, as indicated in Figure 4.1, to notify users of the steep slope beyond. Whether the intended pedestrian route is maintained, or the above modified route is established, the pedestrian route can be indicated by informational "Pedestrian Route" signs at strategic locations.

Street lighting, from boat launch parking to overflow parking,
8 LED overhead lights, 120' o.c. @ \$2,200 ea \$17,600-21,500
(see Figure 4.1 for layout):

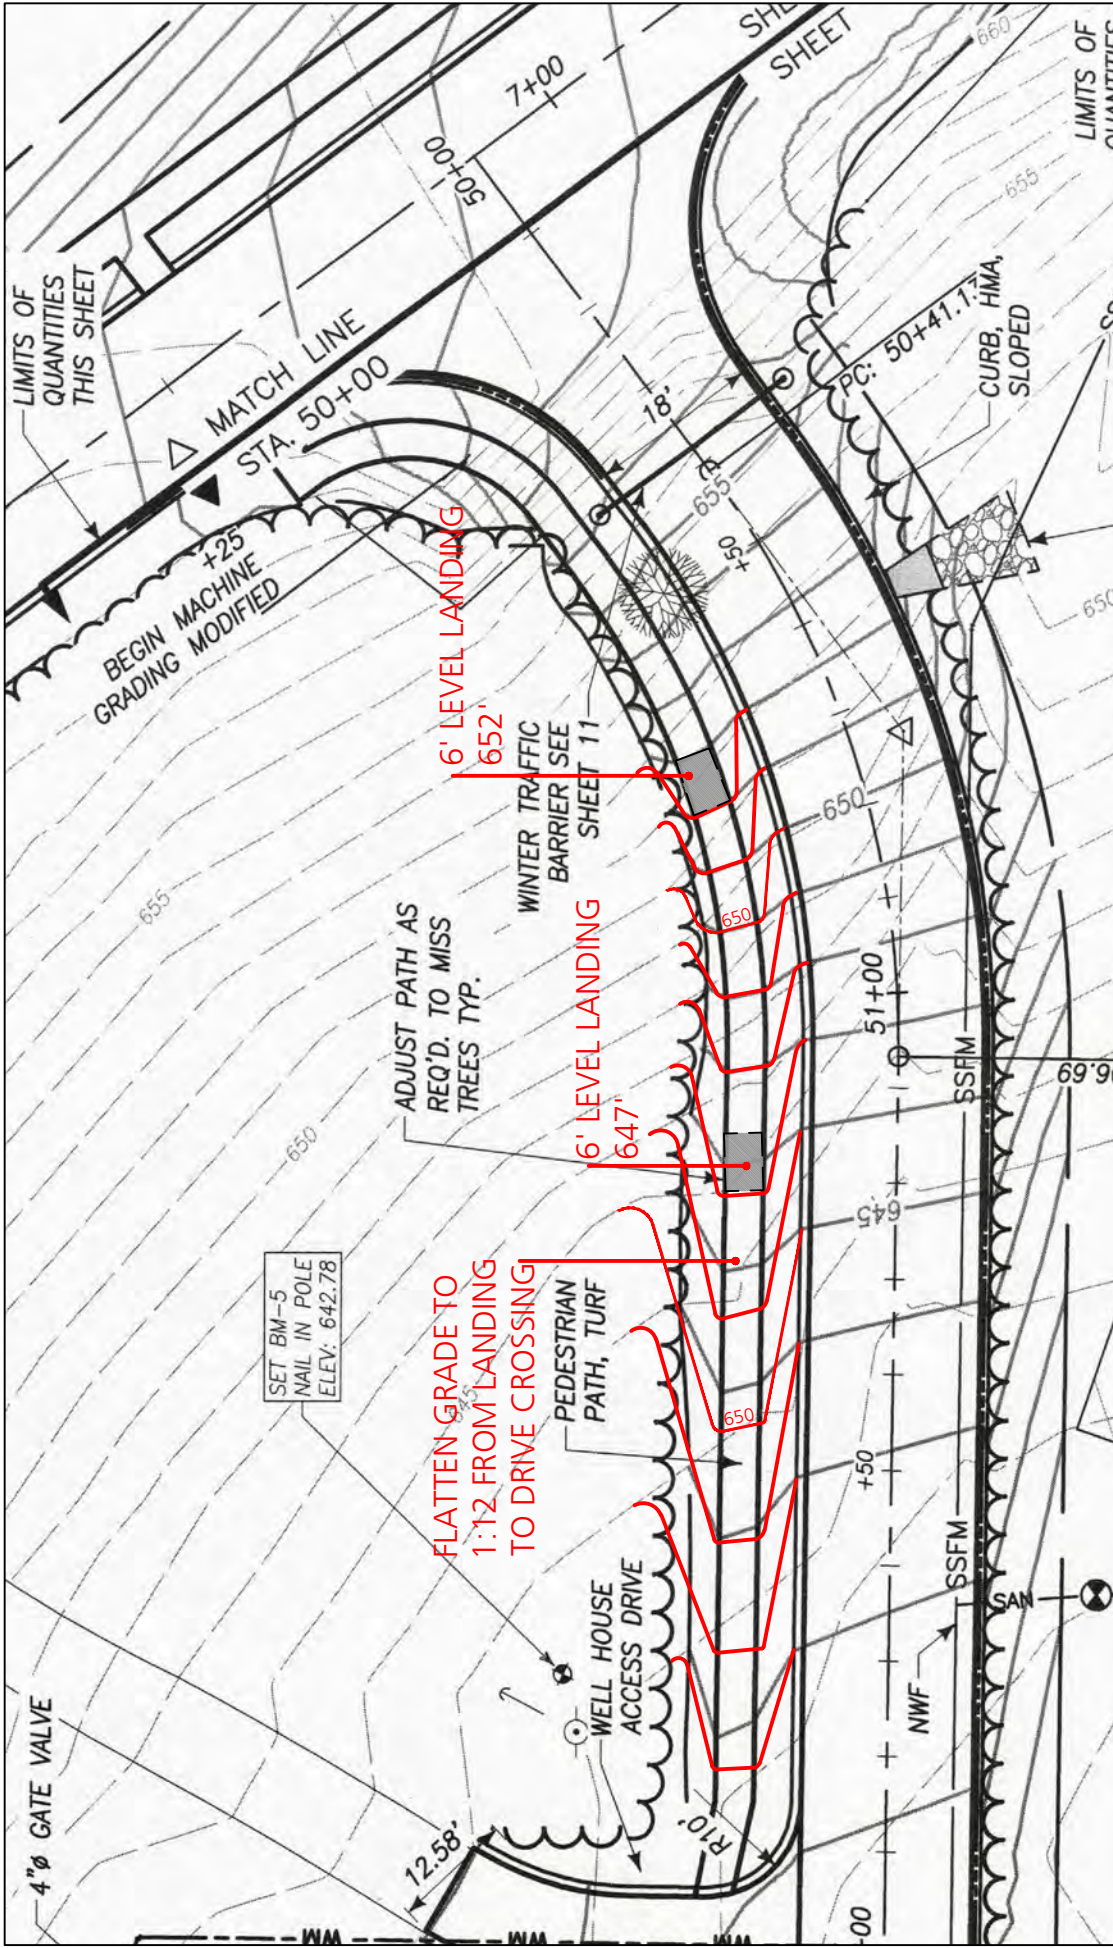
FIGURE 5.1a

The construction plans for the roadside pedestrian path from the boat launch to the main entrance drive measures approximately 550' long and is designed with an overall slope exceeding 10%. The steepest trail segment is a section measuring approximately 190' long, with a grade just over 14%, which can present a significant challenge for many pedestrians. The purpose of the pedestrian path is to facilitate pedestrian movement between the boat launch at lake level and the overflow parking area at upper park level. It does not appear that there is significant space to accommodate overflow parking near the launch at lake level, or at any location within the park that is not at the upper level.

Walking Path Proposed Level Landings
 Boat Launch Drive Sta. 50+00 to Sta. 52.00

The determination above should not imply that an opportunity does not exist to introduce level landings along the path for pedestrians to rest. This assessment previously mentions a 190' segment of trail that exceeds 14%. Referring to Figure 5.1a-c, we have illustrated that by steepening the more gradual trail segments at the top and bottom of the pedestrian path, it should be possible to introduce level landings at approximately 55' intervals along the steepest section of trail, and at lesser intervals throughout. To facilitate the placement of level landings, approximately 80' of 2' precast concrete unit wall would be required to contain the walking surface, as indicated in Figures 5.1 a-c. Given the steepness of the proposed pedestrian path, the existing condition and the impracticality of meeting the AASHTO shared-use pathway standards or the ADAAG accessibility guidelines, our recommendation would be to include the level landings as indicated in Figures 5.1a-c.

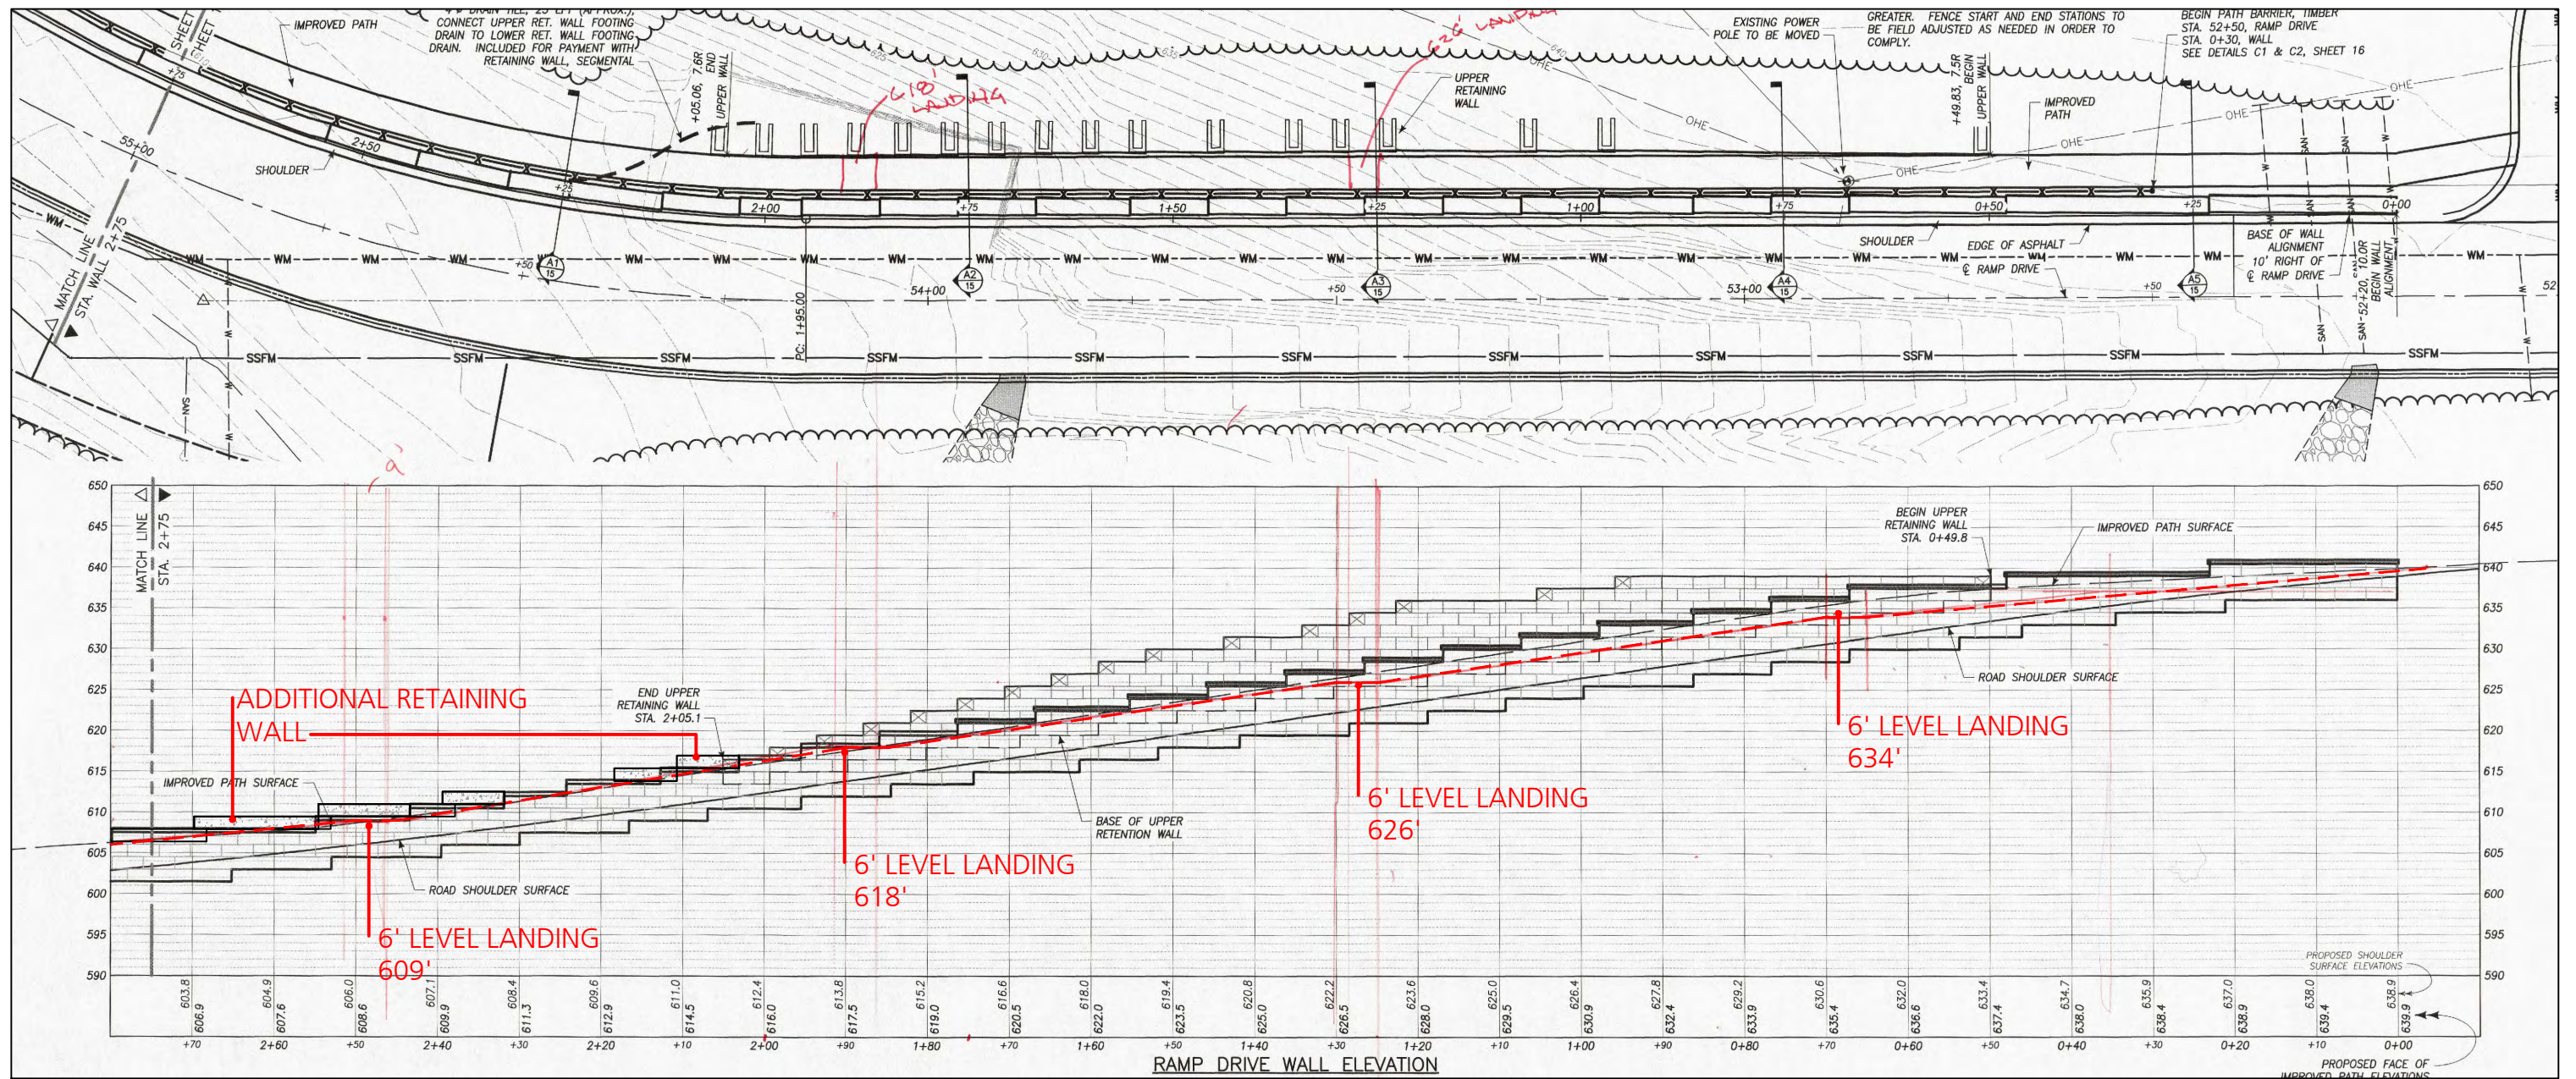
FIGURE 5.1b
 Walking Path Proposed Level Landings
 Boat Launch Drive
 Retaining Wall Sta. 00+00 to Sta. 02+75

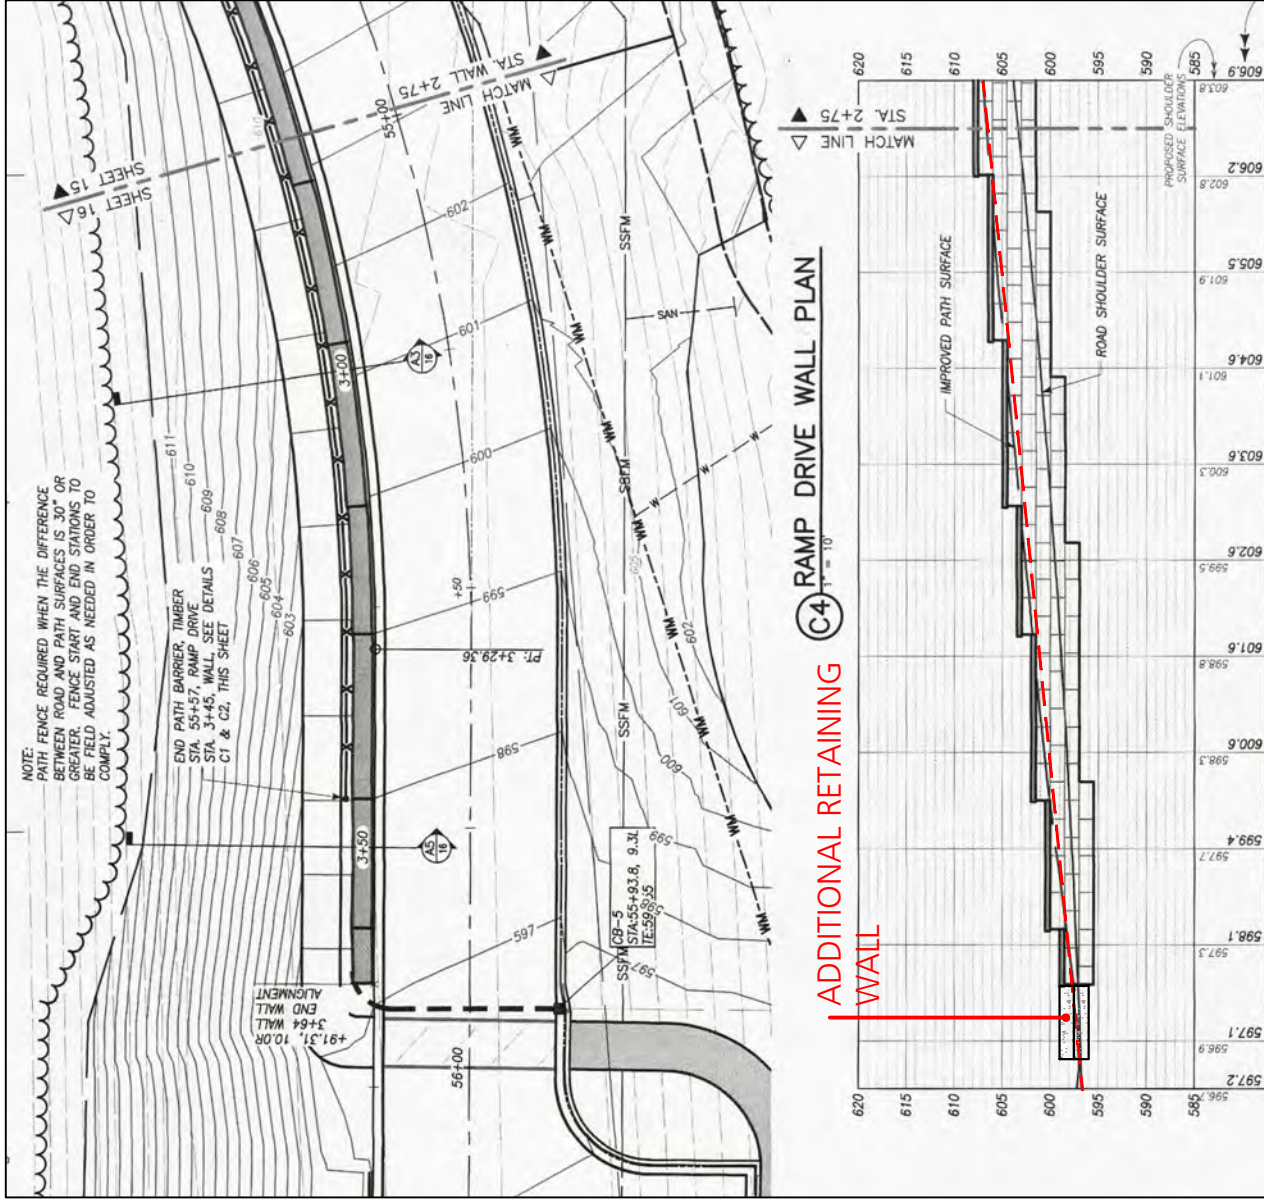
FIGURE 5.1C
 Walking Path Proposed Level Landings
 Boat Launch Drive
 Retaining Wall Sta. 02+75 to Sta. 03+73

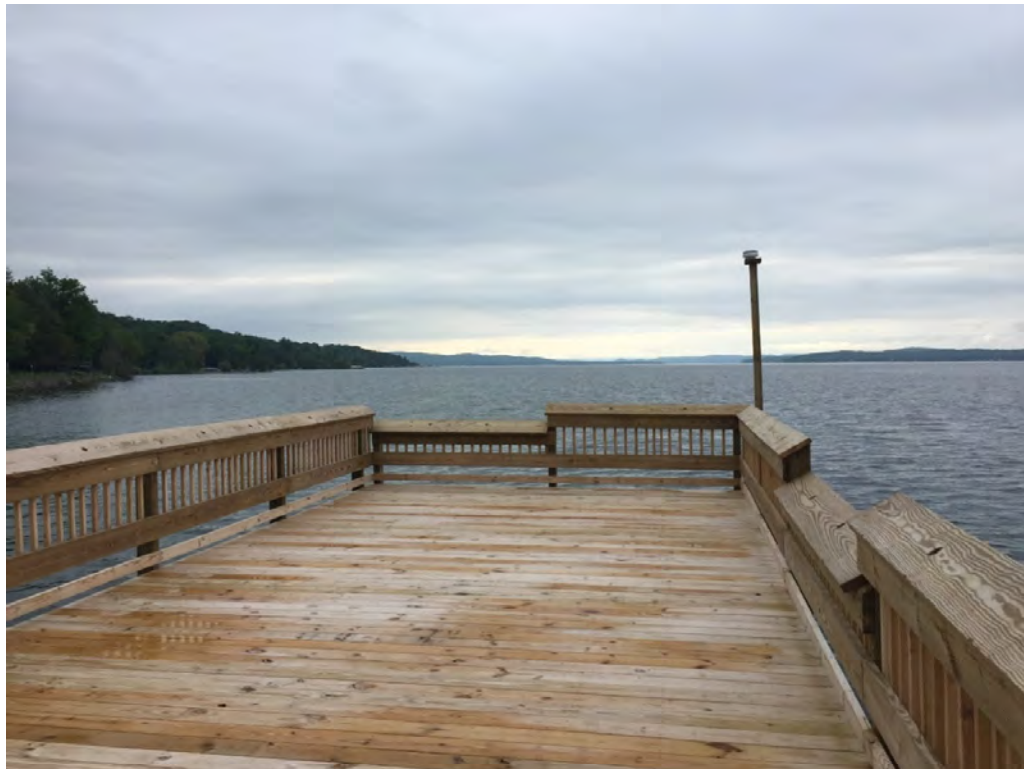
The pier design includes a guardrail installed around the perimeter of the fishing pier. The guardrail varies between a 42-inch and a 32-inch rail height. The higher 42-inch standard rail height meets the most restrictive fall prevention barrier requirement specified by the International Building Code (IBC). The lower 32-inch accessible rail height complies with the ADDAG requirements for fishing piers and platforms. This height provides a person using a wheelchair or other mobility device with the opportunity to fish from the pier. This lower rail height is below the standard IBC guard rail height and inadvertently increases the possibility of a fall occurring.

Photo # - Pier Guard Rail

A life ring would provide someone standing on the pier the opportunity for to assist a person in the water. Life rings need to be strategically placed so that they are readily accessible. The life rings need to be in good working order and have enough line to reach the persons in the water. The line should also be made of a material which allows it to float on the water. This line would also provide the thrower with the ability to retrieve and throw the life ring again. Additionally, the floating line allows the swimmer to grab the line in case the life ring is not accurately thrown. The U.S. Coast Guard promulgates a standard for a 30-inch (76.2 cm) life ring, with at least 90 feet (27.43 m) of line attached. Various agencies specify an installation frequency of 200-feet shall be available at readily accessible points

Various agencies specify an installation of 200-feet shall be available at readily accessible points. Installation of a safety ladder at the inside corner of the pier would provide a water egress location within 200-feet of any point on the pier. In addition, this location is protected from boating activities on the west side of the pier as well as the more exposed wave and wind conditions on the south side of the pier. The ladder should be installed so it extends from the top of the 42" rail down into the water.

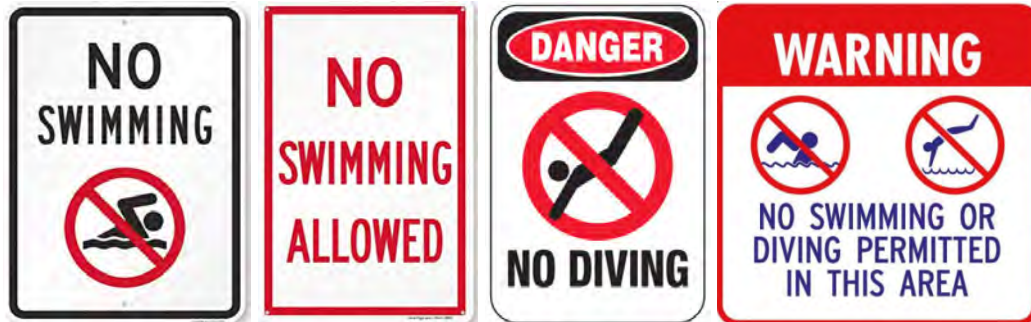
Figure # - No Swimming and No Diving Signs

Signage should be installed on the interior and exterior side of the pier to indicate that swimming or diving from the pier is a prohibited activity. There are a variety of signs available some of which are illustrated in the figure below. These signs can be secured to the wood and metal railings in the vicinity of the pier. Signs should be installed at a minimum on every section of railing at a reasonable frequency.

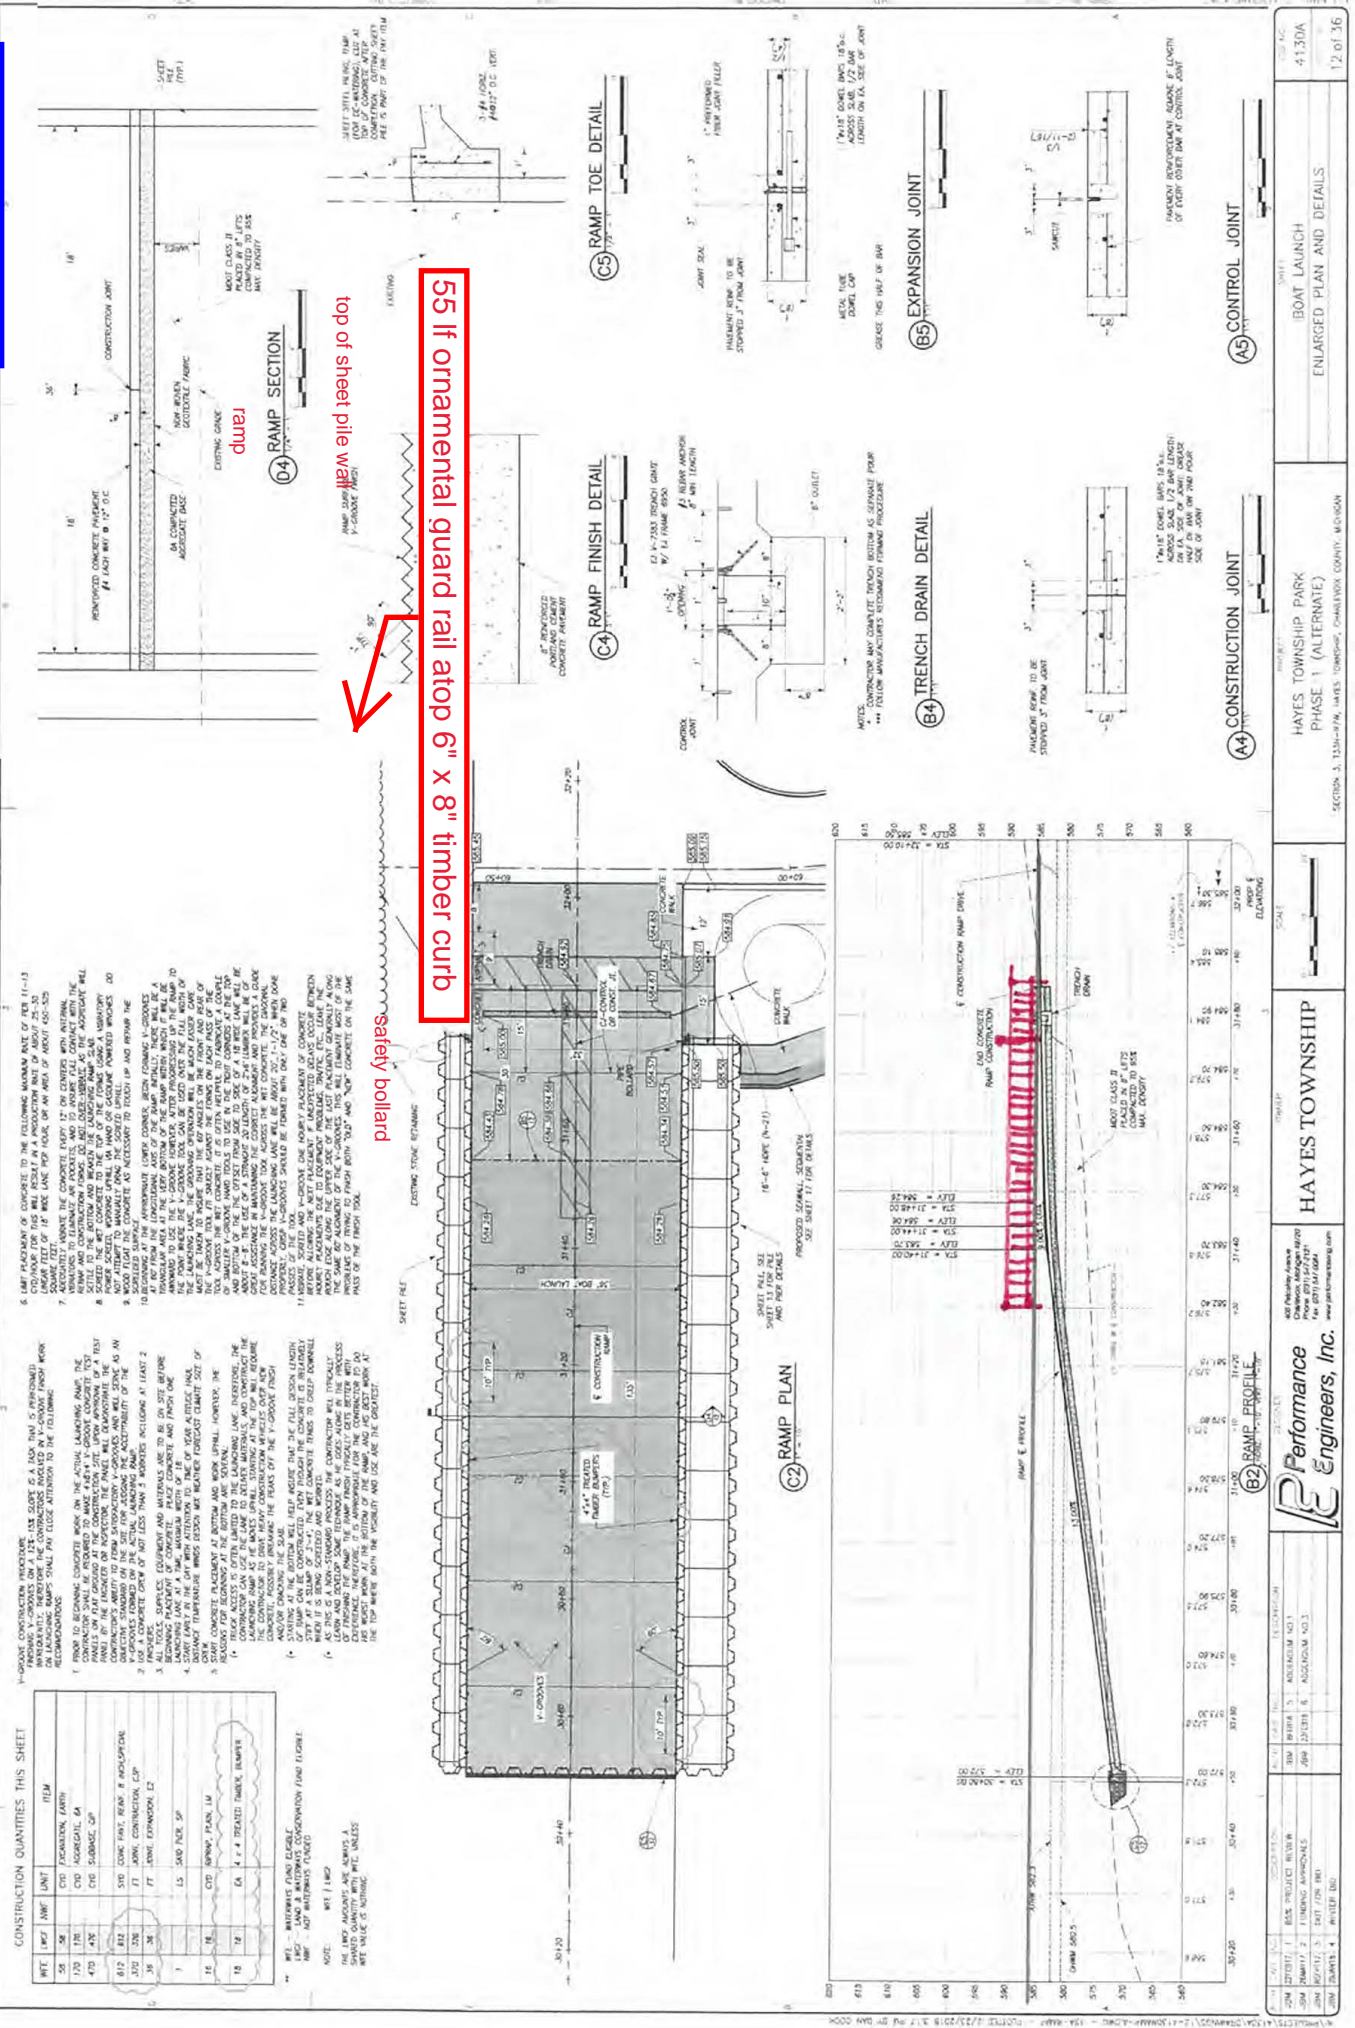
FIGURE 8.1

The sheet pile wall adjacent to the west edge of the boat ramp presents a hazard should people decide to walk along the top of the wall, which is held to just above the elevation at the top of the boat launch. Because the top of the wall is near pavement grade at the top of the ramp, it also presents a challenge for drivers backing into the boat ramp, because there is no clear indication nor significant barrier to notify the driver of the location of the top of wall and edge of ramp.

Add a bumper to help reduce the risk of a car backing over the edge of the wall and ramp and add a guardrail to fulfill the building code requirement that pedestrians be protected from falls exceeding 18" in elevation. Surface-mount guard rail could be installed atop a 6" x 8" timber bumper, which in turn would be mounted on spacers to allow boat ramp surface drainage to pass beneath it. Include 7" x 10" "Danger – Keep Off" sign at north end of wall on guardrail signage prohibiting people from walking or climbing on the wall.

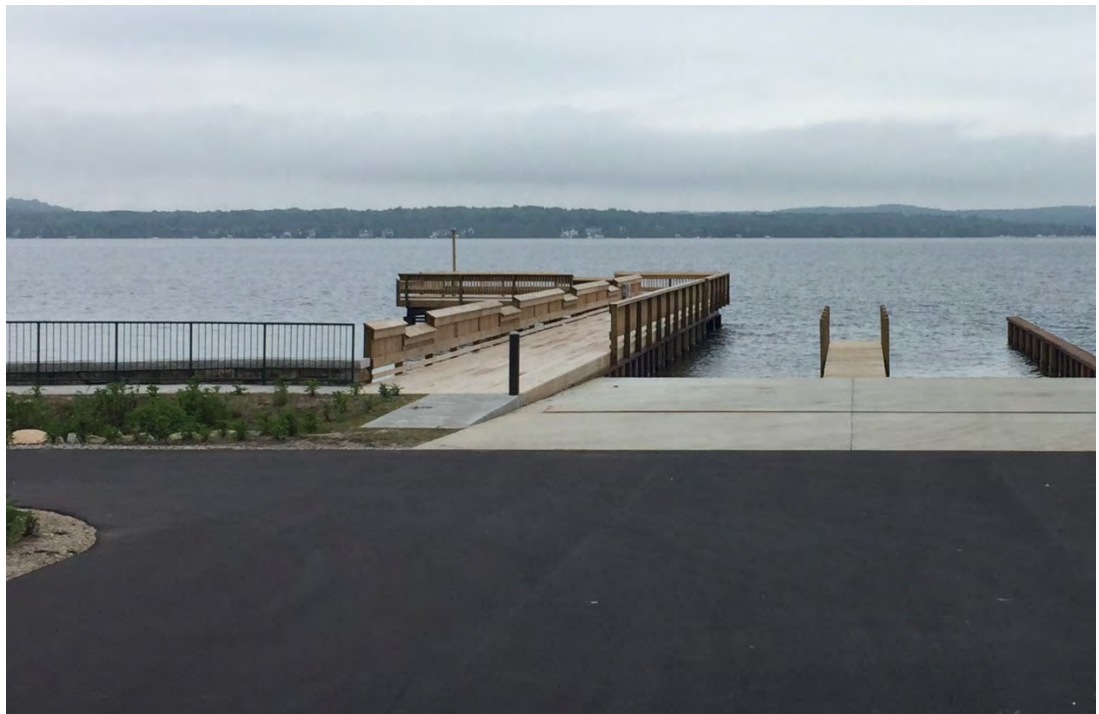
There is apportion of the pier directly adjacent to the boat launch where a guard rail was not installed. The absence of a barrier between the fishing pier and the drop to the concrete boat launch poses a roll-off risk for people in wheelchairs. This issue could be addressed by simply extending the fishing pier rail to the end of the pier.

Photo # - Pier Guard Rail

Extend Fishing pier Rail to the end of the pier (terminate at the steel bollard)

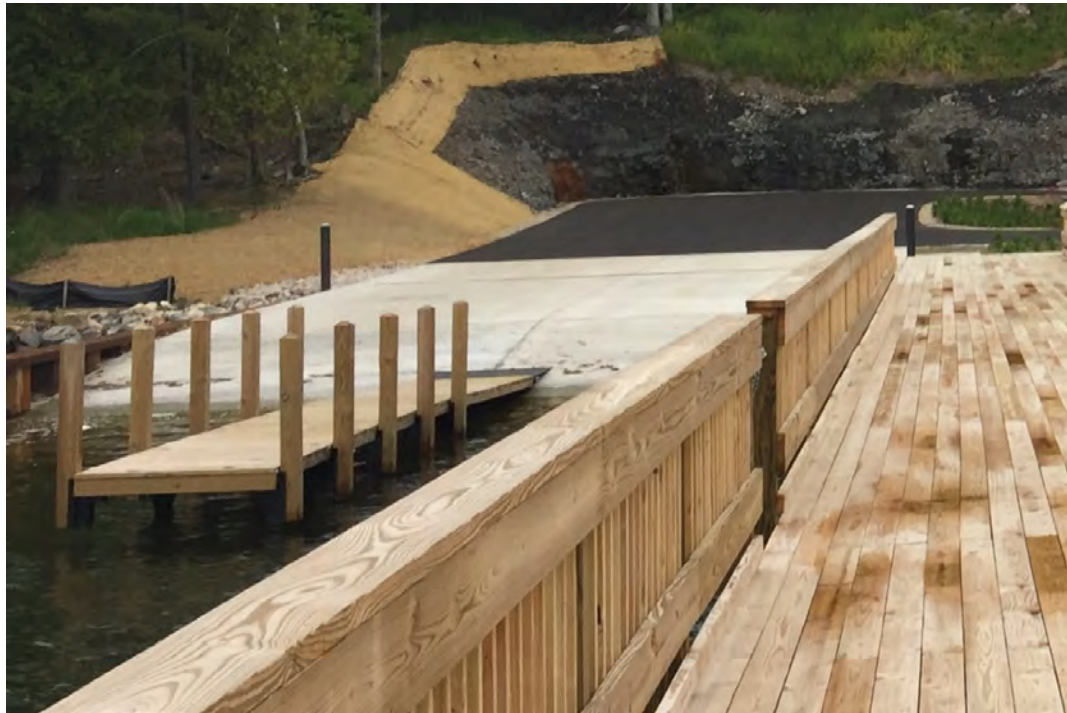
There is an approximately 4-foot gap in the 42-inch tall guard rail along the west side of the fishing pier. We assume that this gap is provided for the purpose of accessing boats that have been launched. However, the boat ramp dock provides access to boats after they have been launched. This guard rail gap poses a fall risk to people on the pier.

Photo # - Gap in Pier Guard Rail

Infill gap in rail with additional 42-inch tall guard rail

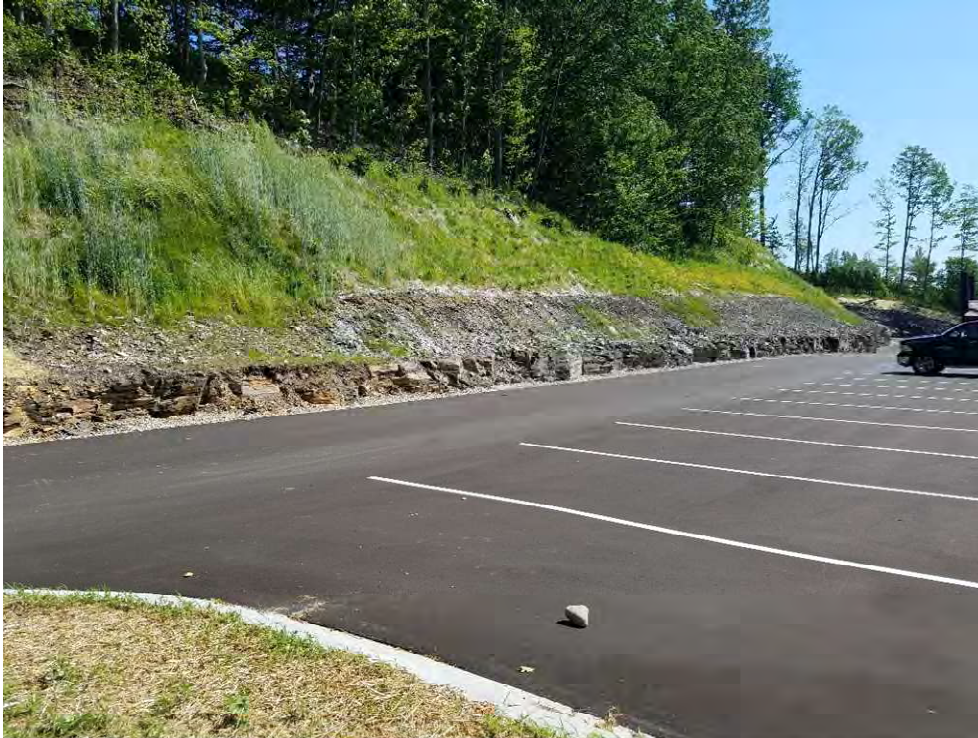
Image looking East

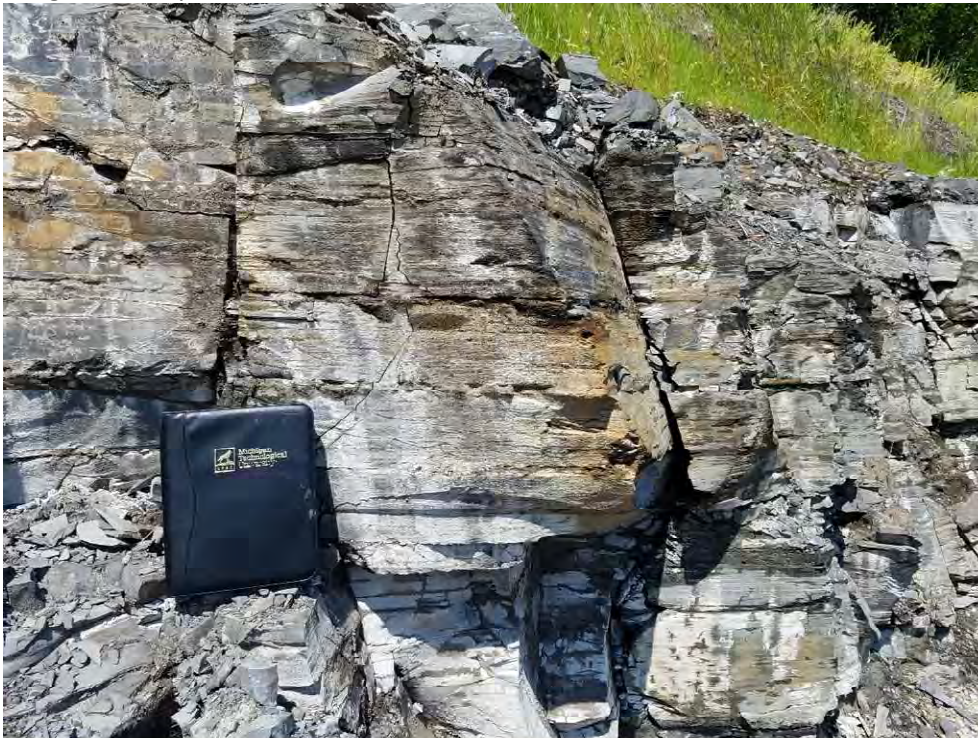
Image of Example Block Fracture

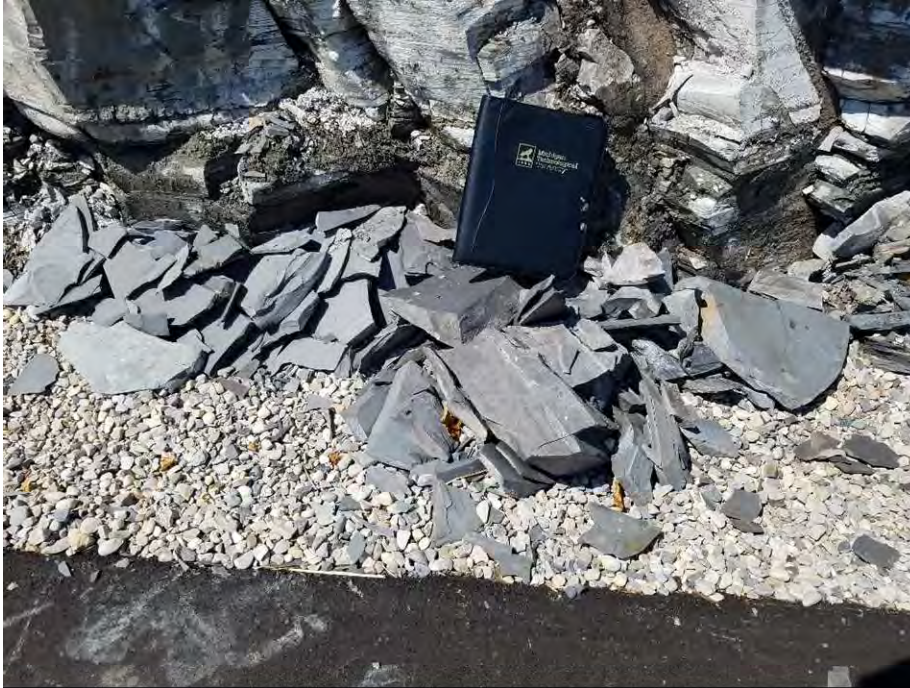
Image of Example Flaking

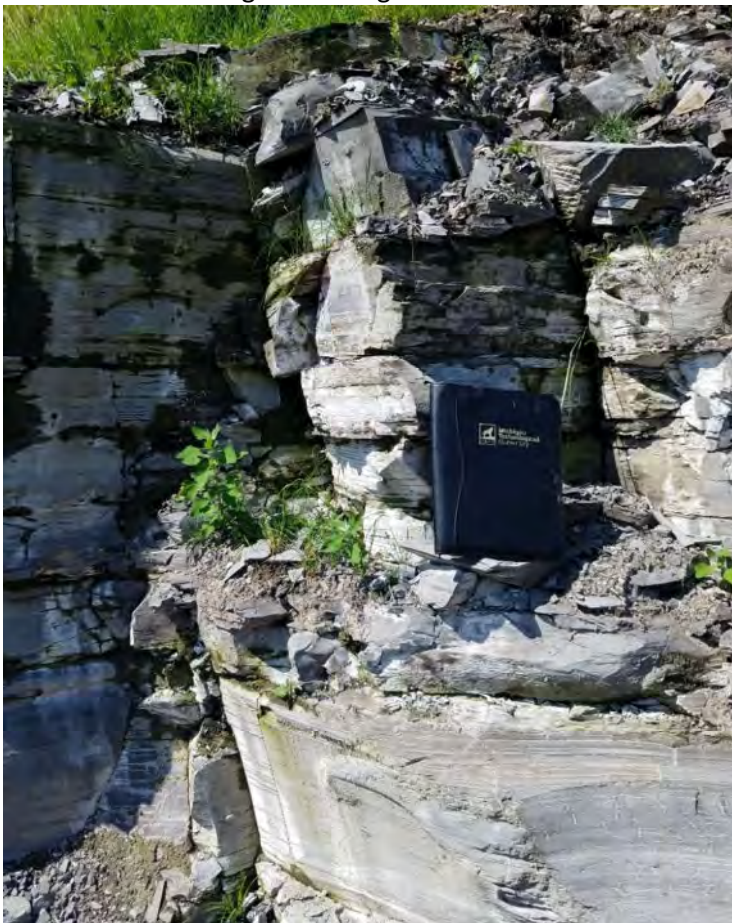
Natural Plants Taking Root along Rock Face

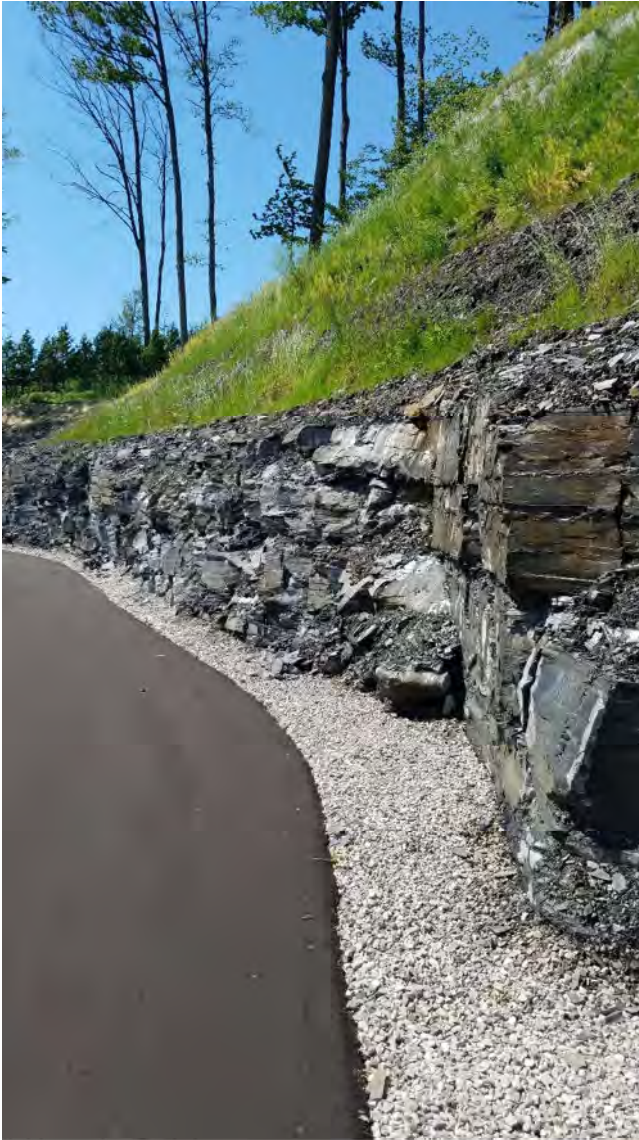
Crushed Stone Ribbon
